# **87C196KR SPECIFICATION UPDATE**

Release Date: December, 1998

Order Number: 272861-004

The 87C196KR may contain design defects or errors known as errata. Characterized errata that may cause the 87C196KR's behavior to deviate from published specifications are documented in this specification update.

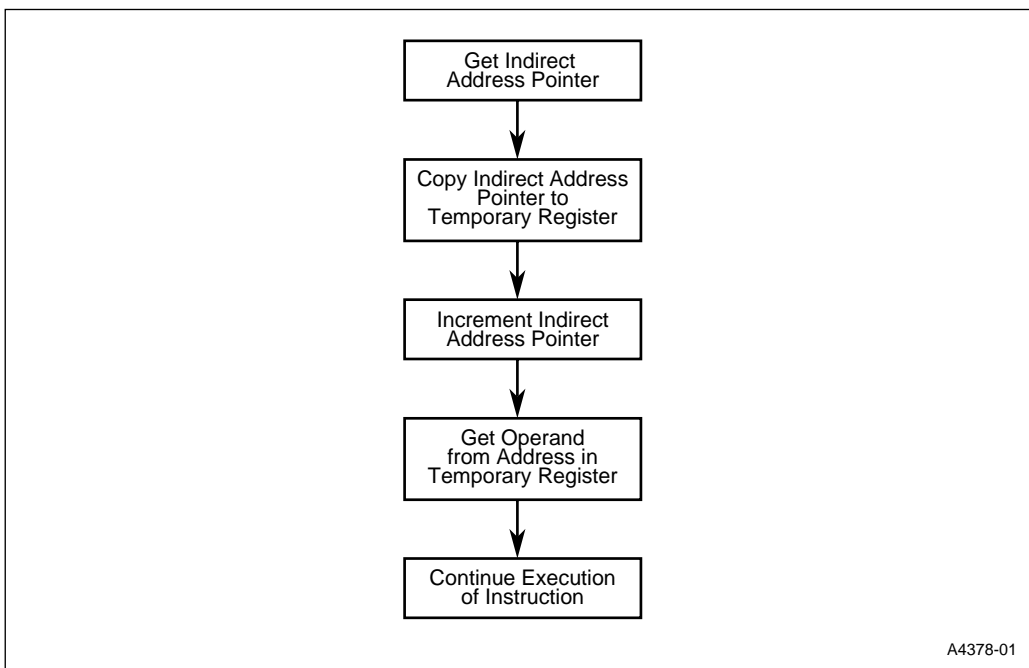
**PROBLEM:** For indirect addressing with autoincrement, a pointer that points to itself results in an access to the incremented pointer address rather than the original pointer address.

The CPU stores the pointer's value in a temporary register, increments the pointer, then accesses the operand at the address contained in the temporary register, as shown in this flowchart.

Therefore, if the pointer points to itself, the CPU accesses the operand at the incremented address contained in the pointer.

**WORKAROUND:** Avoid using an indirect address pointer that points to itself.

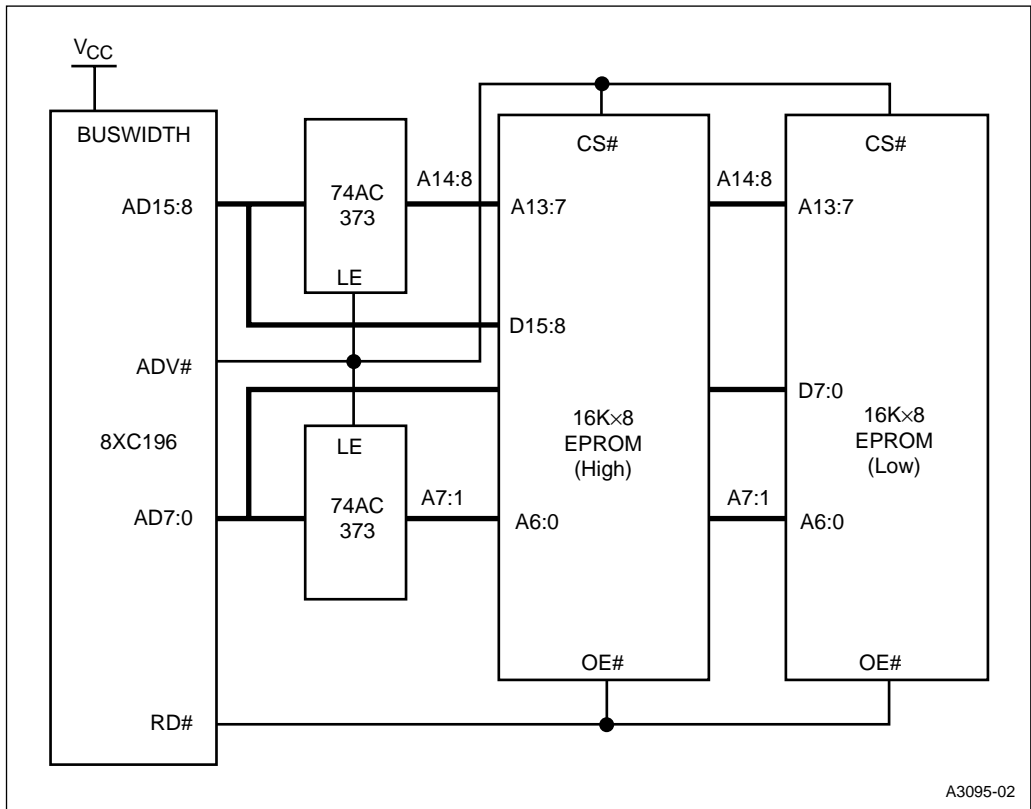
Figure 1. 16-bit System with EPROM

1. **High Address Inputs to the Low EPROM Should be A14:8 in Figure 15-18.**

**ITEM:** The next revision of the user’s manual will include the following corrected graphic.
