INTERNAL CORRESPONDENCE

SUBJECT: ECO Matrix and rework for IPB, IOC, DRR Boards REV 3

This document contains the rework required to up-grade the IOC, IPB, DRR Channel and interface boards to the latest correct dash and REV level.

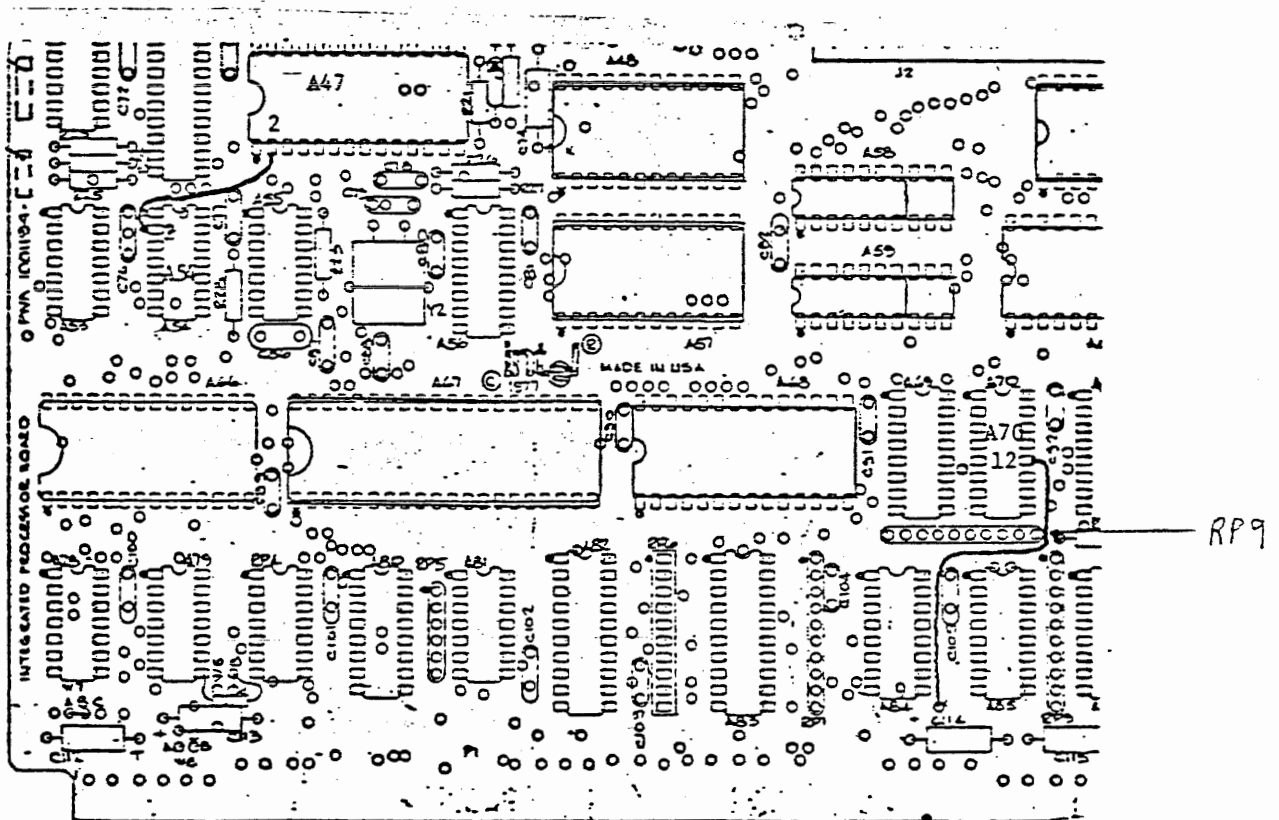
FIGURE 1

ECO 2-4594A

3. On solder side, cut the trace running from RP9-3 to the feed thru located near A84-9. (See figure 1).

4. On component side, install a jumper from the feed thru located below and to the right of A84-9 to A70-12.
5. On component side, install a jumper from the lead of A54-2 to A47-2.

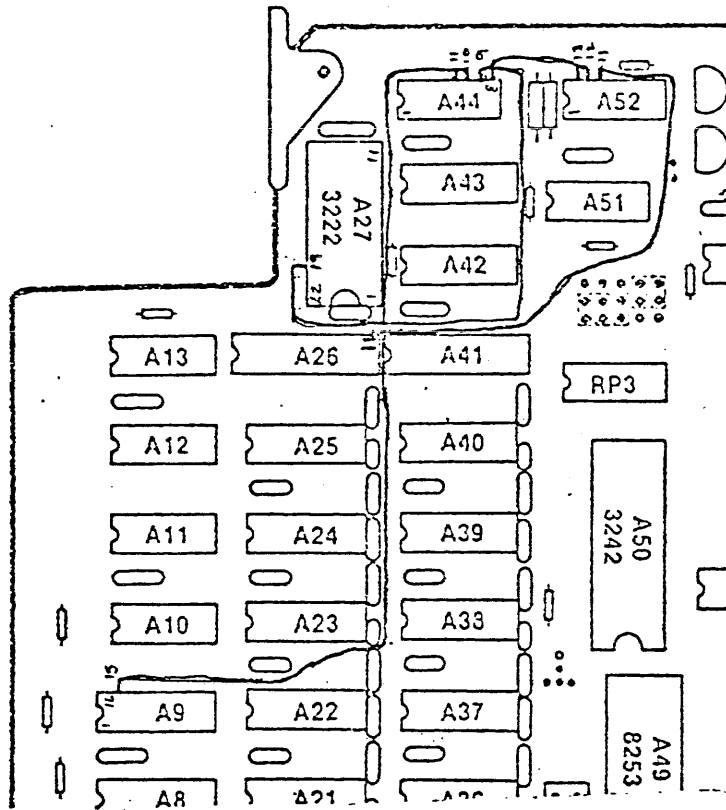
FIGURE 1

ECO 2210

1. Replace all 74S74 (100913-001) with 74LS74 (100914-001)
2. Cut trace from A9-15 to A26-11
3. Add jumpers as follows, (see figure 1):

<u>FROM</u>	<u>TO</u>
A27-19	A44-9
A9-15	A44-10 & 11
A44-8	A52-12 & 13
A52-11	A26-11

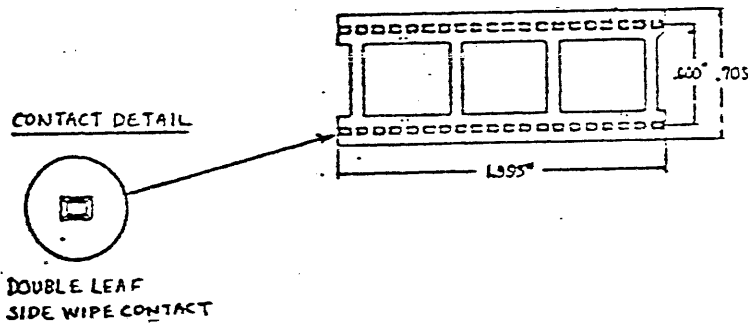
ECO 2-4565

1. Remove 40 pin IC's at locations A1, A20, A58, A69 and A72.
2. Inspect 40 pin sockets for the type shown below:
The 40-pin sockets to be replaced are Intel P/N 68-234 (typical example shown below)

3. If PWA does not have this type of socket, replace IC's in sockets (sockets are then of the right type).
4. If PWA does have the above sockets, remove all 40-pin sockets shown above.
5. Replace 40-pin sockets with Scanbe or Augat type (P/N 102989-00 or 101581-040)
6. Replace IC's in sockets

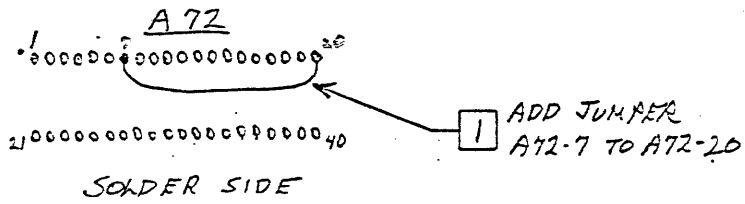
ECO 2-3774

1. Add jumper from A72-7 to A72-20 (gnd) or equivalent

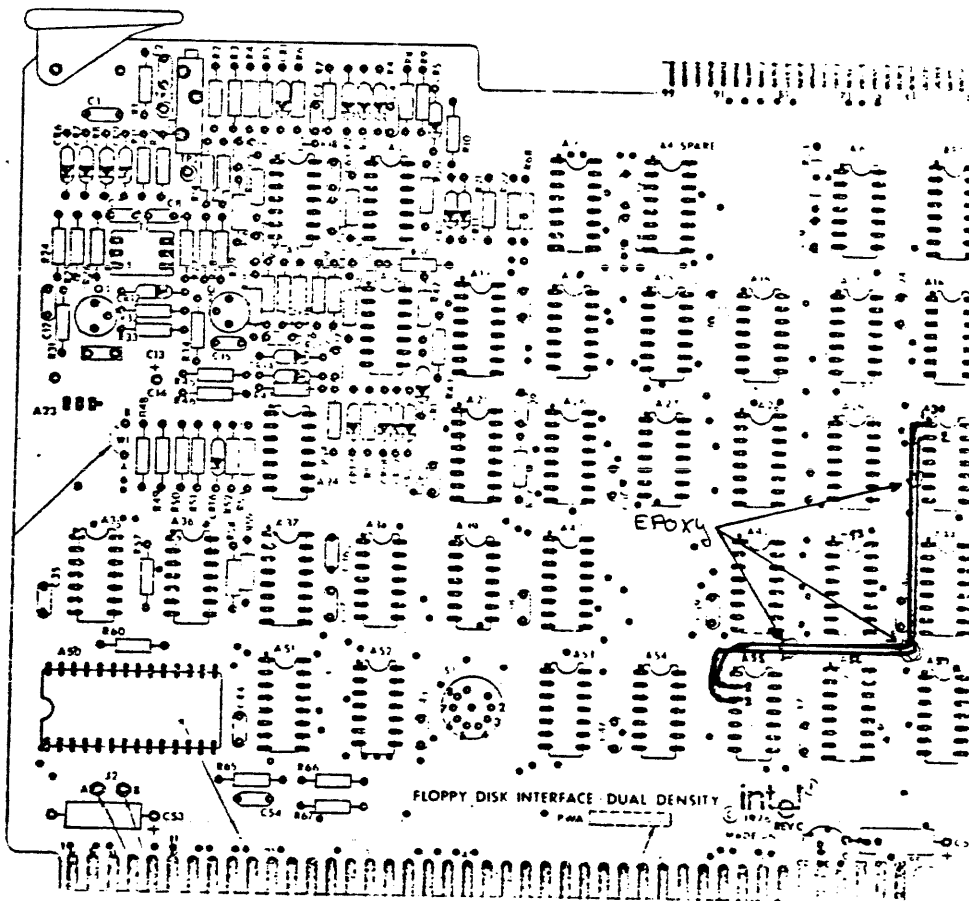
ECO 1805

1. Remove Pin 3 A55 from the board and cut the pin off as close to the body of the IC as possible.
2. Add a wire from A30 Pin 1 to A55 Pin 2 using 22 gauge wire.
3. Add a wire from A30 Pin 2 to the pad where A55 Pin 3 was formerly located.
4. Epoxy at point shown in figure below:

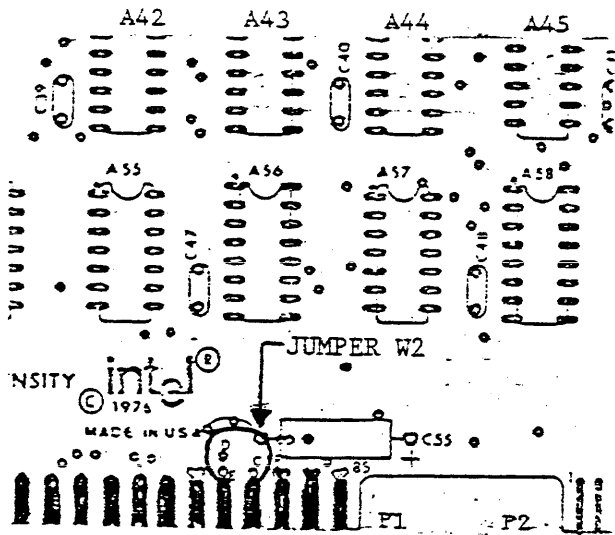
ECO 3841

1. Location of jumper W2 must be changed from D to C and changed to D to E, to utilize -10V power supply in Series II.
